# SERVICE MANUAL

DATSUN 240Z SPORTS  
MODEL S30 SERIES  
**CHASSIS & BODY**

## STEERING

### STEERING SYSTEM

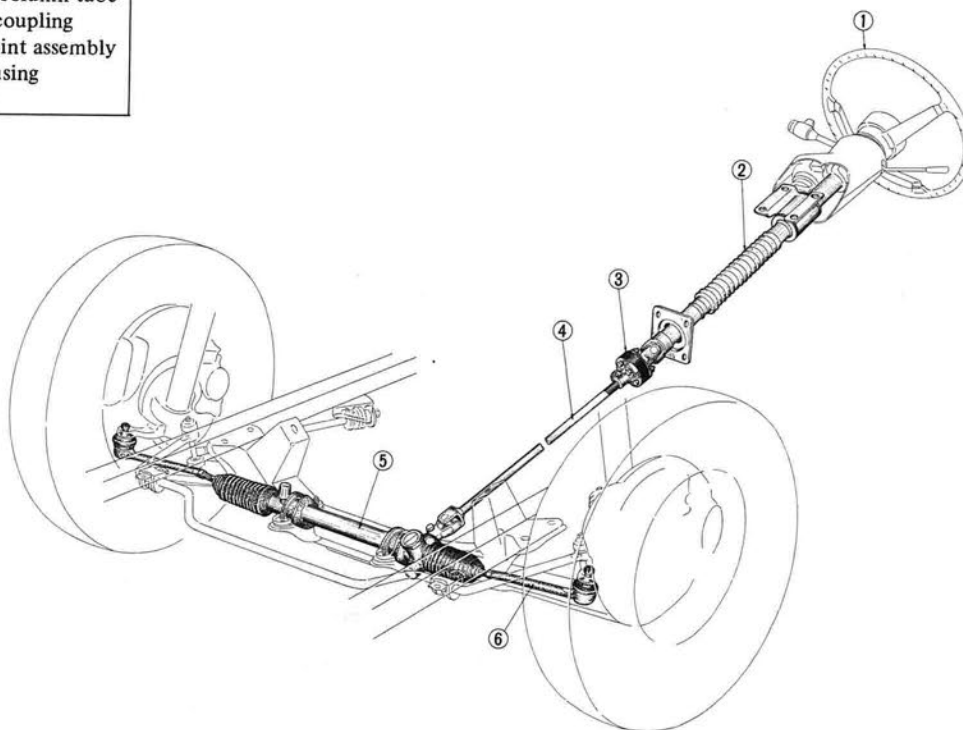
Fig. ST-1 Steering gear components

The steering assembly is a direct-acting rack-and-pinion type with a gear ratio 17.8 : 1, providing sharp, light, and accurate control under all conditions.

It consists of a rack bar and toothed pinion, both

working in the plain bearing of the housing. Backlash is held to 0 mm (0 in) by the retainer and the retainer spring.

- |   |                      |

| 1 | Steering wheel |
| 2 | Steering column tube |
| 3 | Rubber coupling |
| 4 | Lower joint assembly |
| 5 | Gear housing |
| 6 | Side rod |

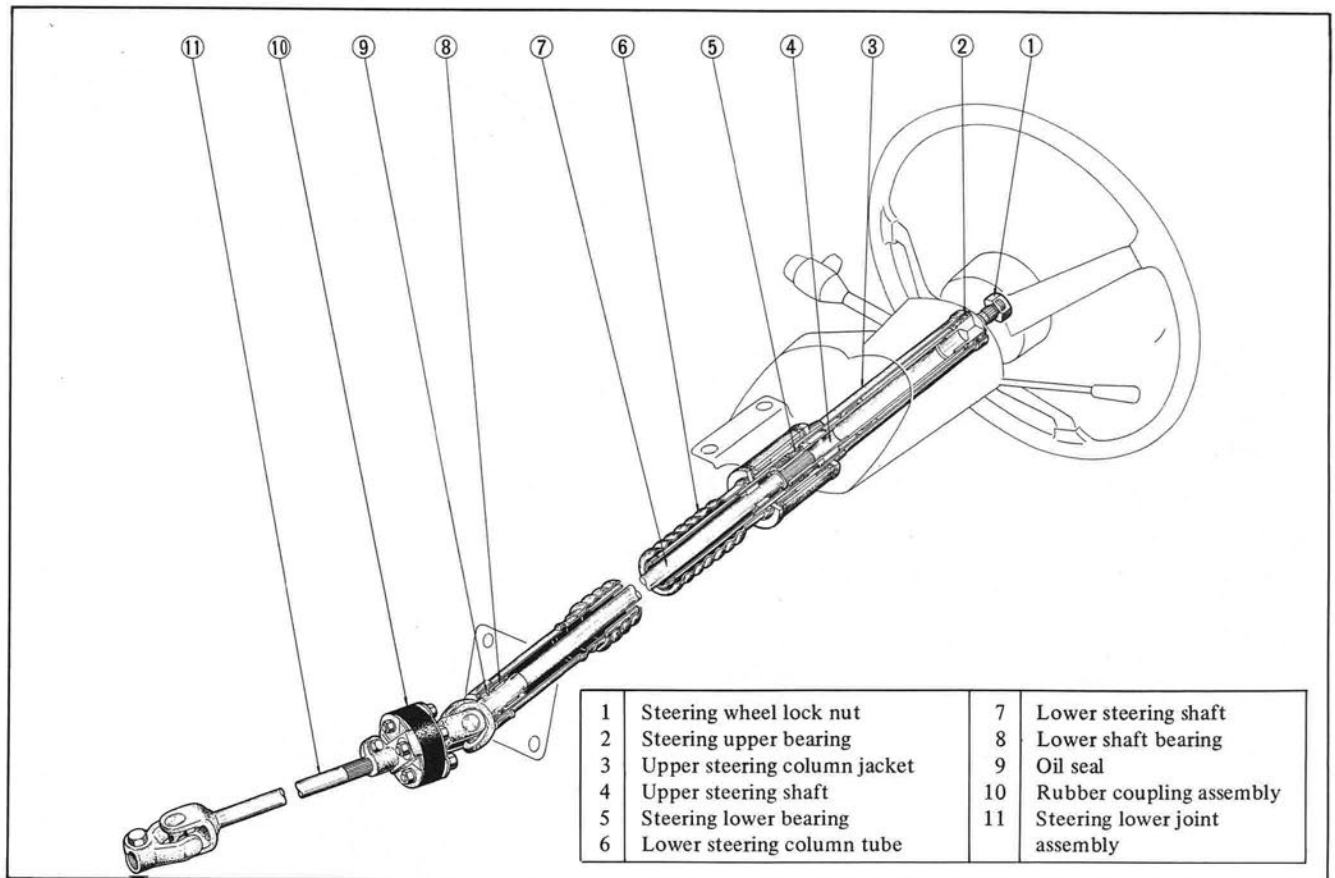
Fig. ST-2 Steering column assembly

The steering wheel is a cone type which exhibits excellent safety characteristics. Between the steering wheel and gear assembly, a rubber coupling is used to prevent the vibration from the road surface, insuring excellent handling and safety, and two universal joints are used between the gear assembly and steering wheel to give the most suitable steering wheel position and angle.

The collapsible steering column is designed to compress under impact. When an automobile is being driven, the forward movement of the automobile and the forward movement of the driver both constitute a form of energy or force. When an automobile is involved in a head-on collision, the primary force (forward movement of the car) is suddenly halted, while the secondary force (the driver) continues in the forward direction. A severe collision generally involves these two forces primary and secondary. The secondary impact occurs when the driver is thrust forward onto the steering wheel and column.

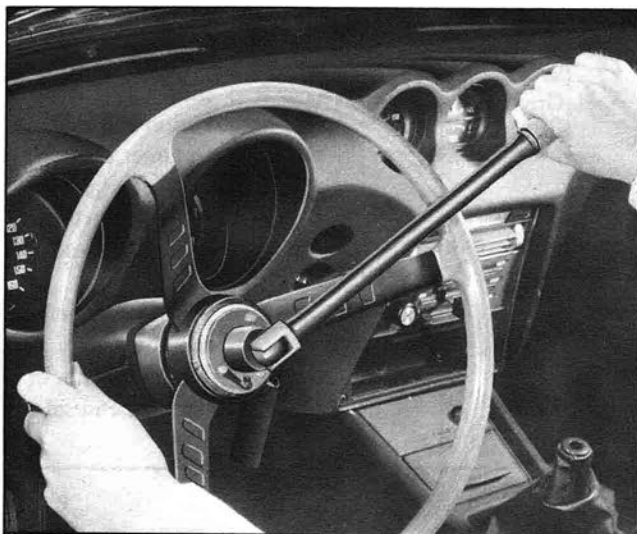
*Fig. ST-3 Removing steering wheel*

1. Remove the horn button by pulling rearward. Remove the steering wheel after removing the steering wheel nut.

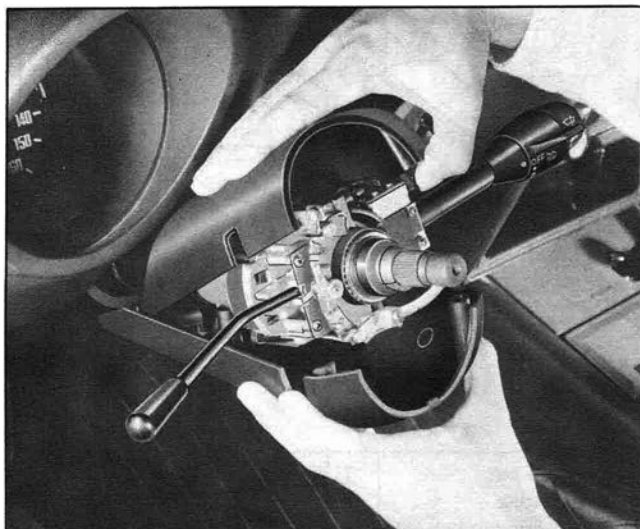
*Fig. ST-4 Removing shell cover*

2. Remove upper and lower steering column shell covers by loosening six screws. Then loosen two screws retaining the turn signal and lighting switch assembly to steering column and remove the switch assembly.

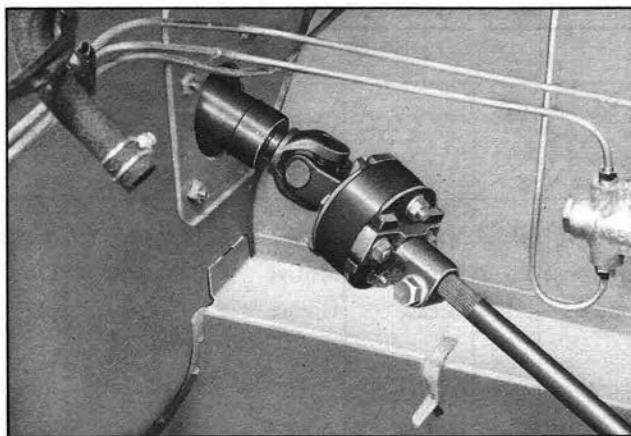
*Fig. ST-5 Rubber coupling bolt*

3. Disconnect the steering column assembly from lower joint shaft at the rubber coupling by removing two bolts.

Steering wheel nut:	4 to 5 kg-m (28.9 to 36.2 ft-lb)
Rubber coupling bolt:	1.5 to 1.8 kg-m (10.8 to 13.0 ft-lb)

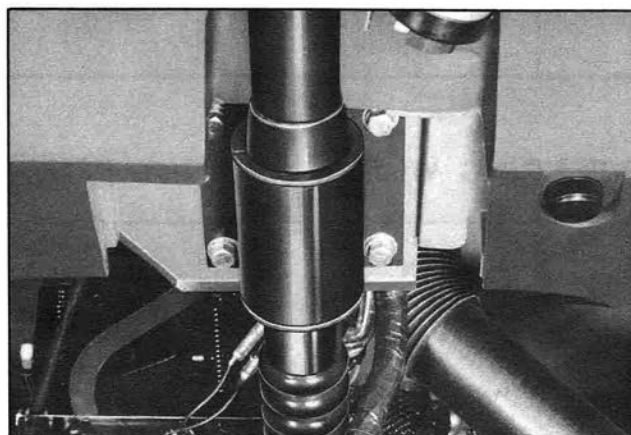
*Fig. ST-6 Removing steering post clamp*

4. Remove the steering post clamp by removing four bolts.

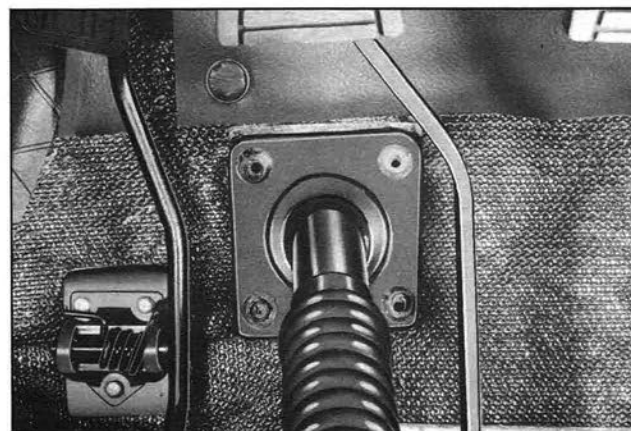
*Fig. ST-7 Removing column bracket bolts*

5. Remove the four bolts securing the steering column grommet to the dashboard. The steering column assembly can then be removed into the room, remaining the lower steering shaft in the engine compartment.

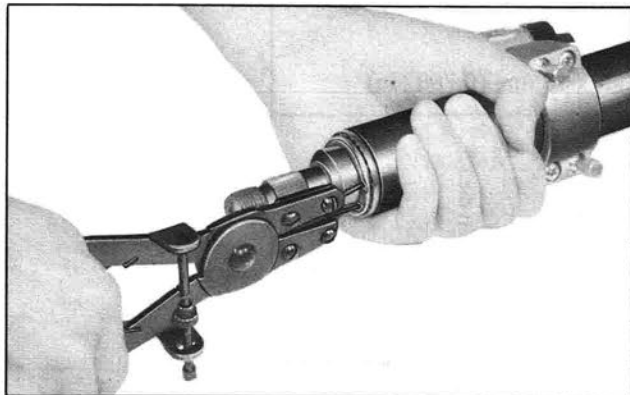
Fig. ST-8 Removing snap ring

2. Remove a snap ring and spacer ring at the upper end of the upper column, and extract the upper column shaft from the steering upper column jacket.

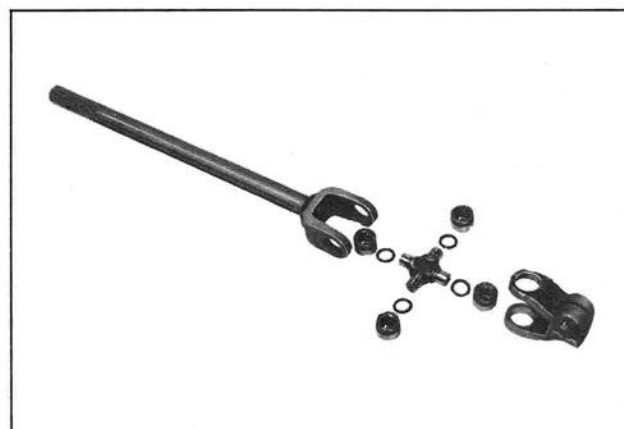
Fig. ST-9 Steering lower joint components

4. Remove the snap ring and disassemble the steering lower joint.

**Note: Do not disassemble the joint unless otherwise defects found.**

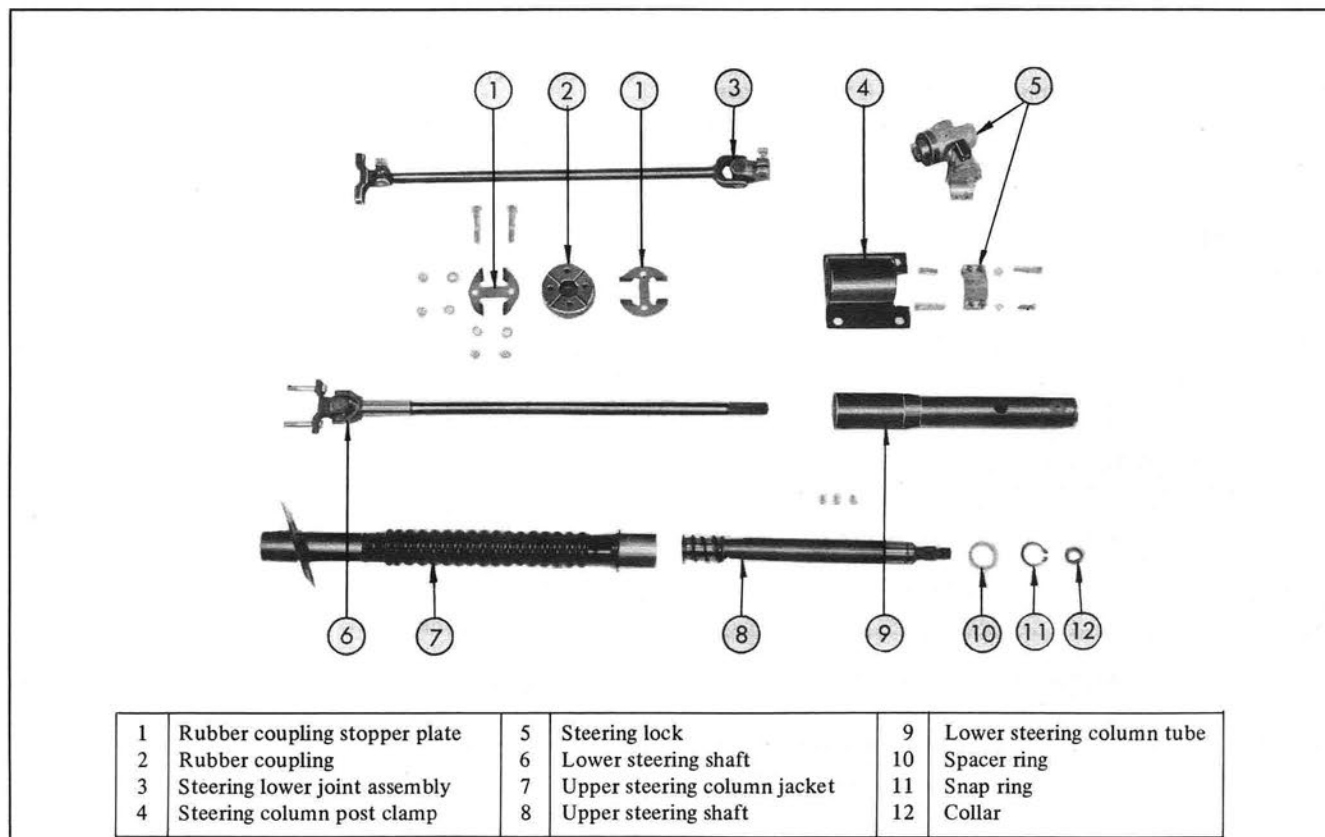
Fig. ST-10 Components of steering column assembly

Thoroughly clean and examine all parts of the assembly; components showing signs of wear, chipping, or damage must be replaced with new parts.

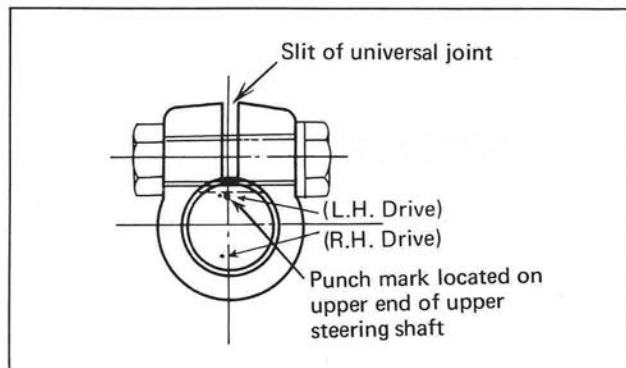
Fig. ST-11 Aligning slit with punch mark

**Note:** When the lower steering shaft spline is fit the upper steering shaft spline, the slit of the universal joint must coincide with the punch mark located on the upper end of the upper steering shaft (See figure ST-11).

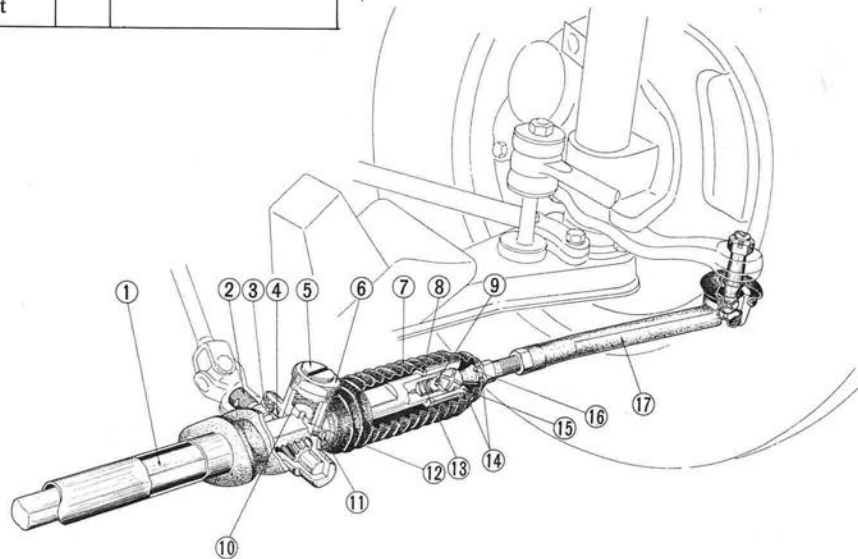
Fig. ST-12 Cross-section of rack-and-pinion with side rod assembly

1	Rack	10	Retainer spring
2	Pinion	11	Filler plug
3	Oil seal	12	Retainer
4	Pinion bearing	13	Side rod inner spring
5	Retainer adjust screw	14	Dust cover clamp
6	Lock nut	15	Side rod inner socket
7	Gear boot	16	Ball stud
8	Lock nut	17	Side rod assembly
9	Side rod spring seat

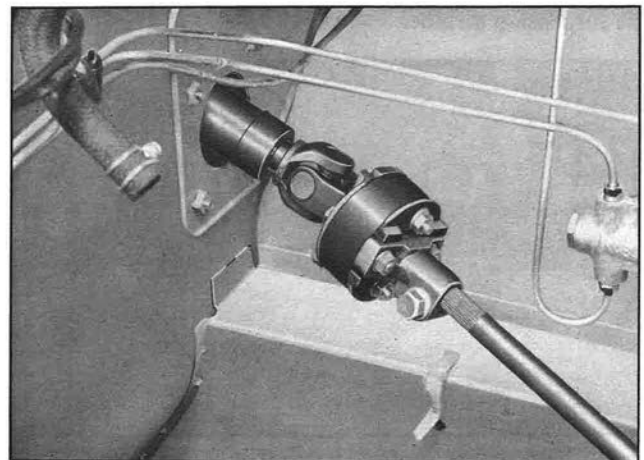
Fig. ST-13 Rubber coupling bolts

2. Disconnect the steering lower joint from the steering column at the rubber coupling by removing two bolts.

Loosen the bolt securing the steering lower joint to the pinion, and then remove the lower joint assembly from engine compartment.

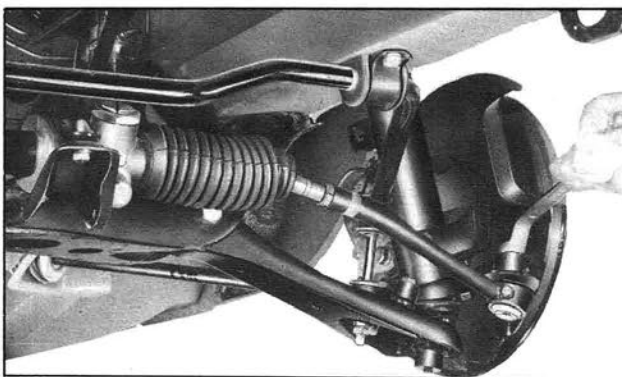
*Fig. ST-15 Disconnecting side rod socket*

4. Remove the side rod ball stud nut and disconnect the side rod from the knuckle arm.

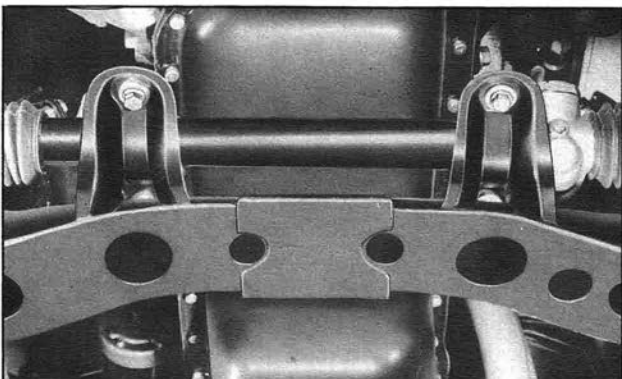
*Fig. ST-16 Bolts securing housing to the suspension member*

6. Remove bolts securing the steering gear housing to the suspension member.

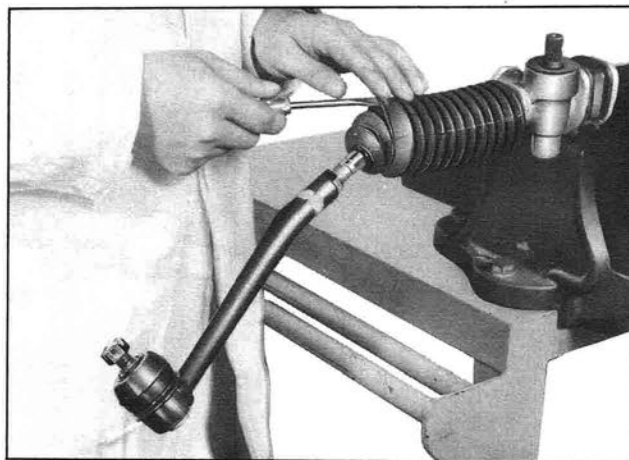
*Fig. ST-17 Removing dust cover clamp*

1. Disconnect the steering lower joint from the rack-and-pinion assembly.
2. Clamp the rack-and-pinion assembly in a vise by using patches on the steering gear housing to avoid scarring.
3. Remove the dust cover clamp and boot clamp from the steering gear boot. (Both left and right.)

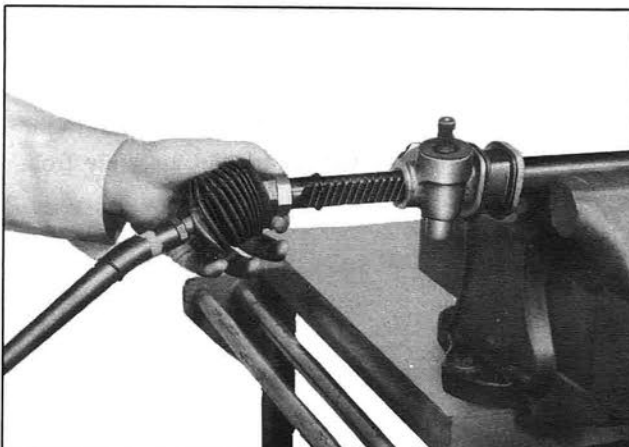
*Fig. ST-18 Removing side rod assembly*

4. Loosen the stopper nut, remove the side rod inner socket, and disconnect the side rod assembly from the rack.

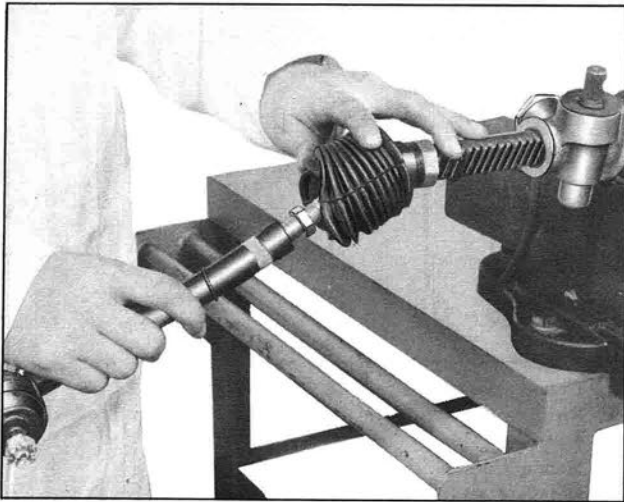
*Fig. ST-19 Removing side rod outer socket*

5. Withdraw the spring seat and side rod spring.
6. Detach the steering gear boots. (Both left and right hand.)
7. Loosen the side rod lock nut and disconnect the side rod outer socket assembly from the side rod ball.

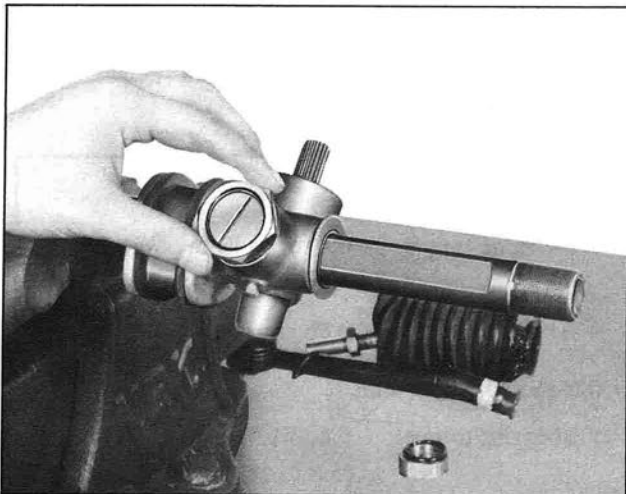
*Fig. ST-20 Removing lock nut*

8. Loosen the lock nut and remove the retainer adjust screw. And then take out steering gear retainer.

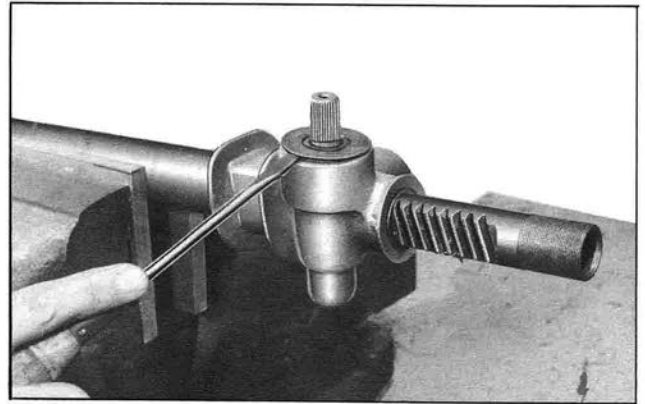
*Fig. ST-21 Removing oil seal*

9. Pry off the oil seal.

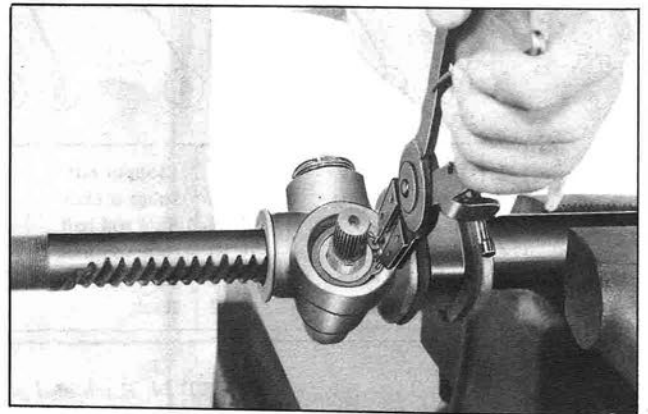
*Fig. ST-22 Removing snap ring*

10. Remove the snap ring and draw out the steering pinion assembly.

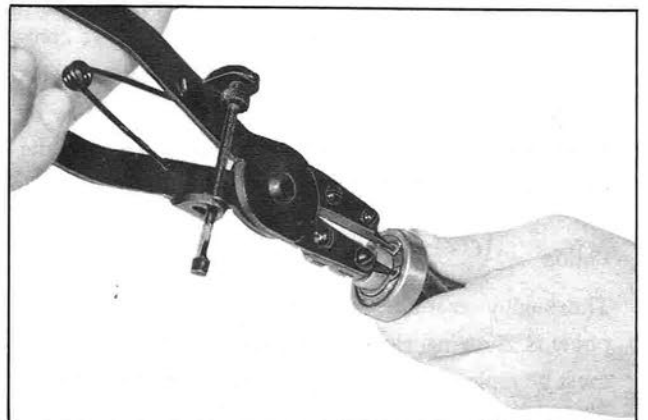
*Fig. ST-23 Removing snap ring*

11. Remove the snap ring and draw out the bearing from the pinion.

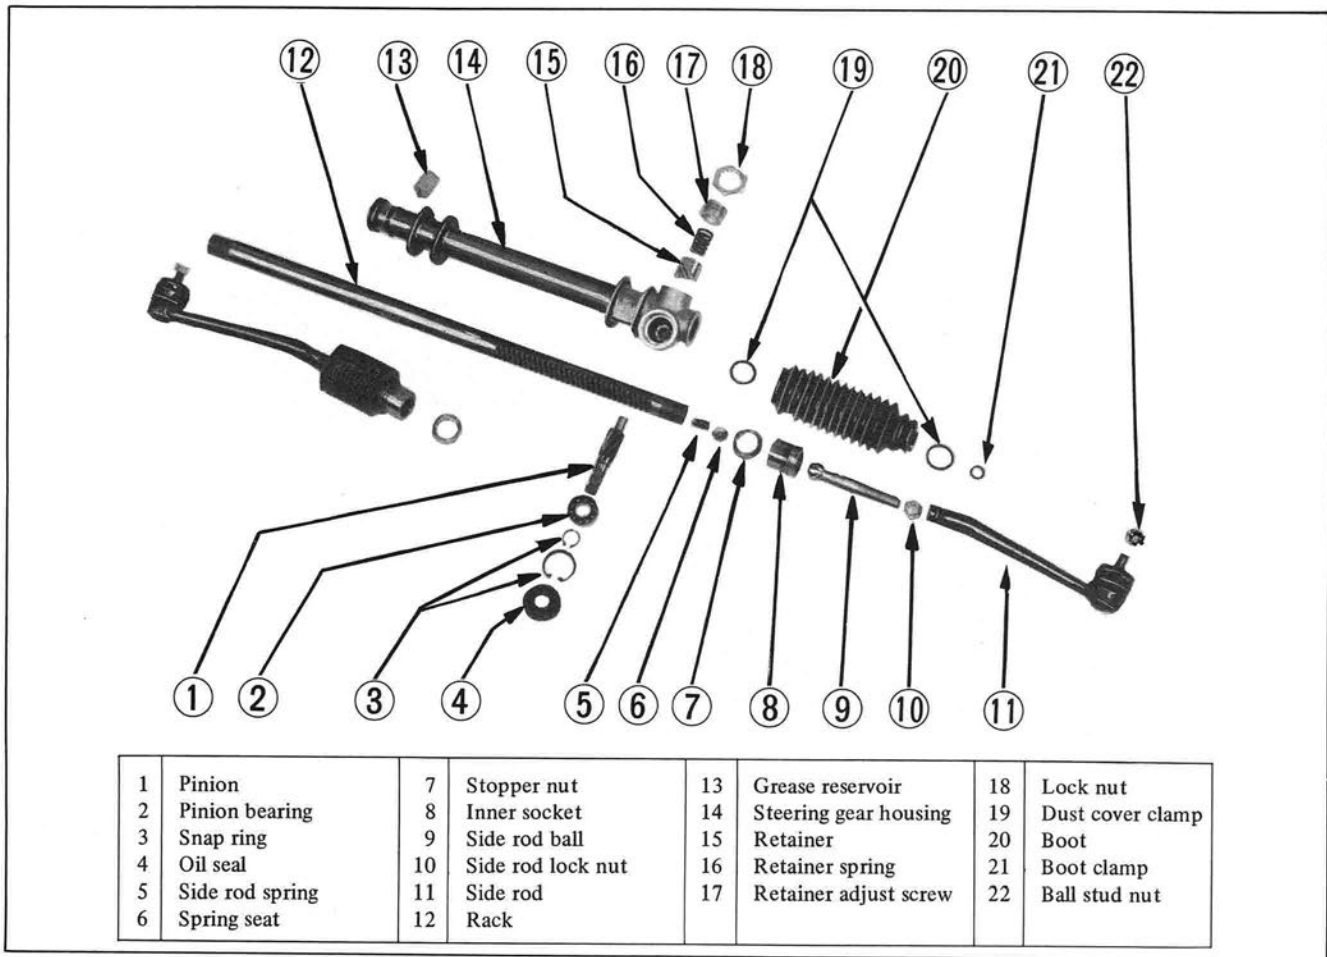
Fig. ST-24 Rack-and pinion and side rod components

Thoroughly examine all parts of the assembly; components showing signs of wear must be replaced with new parts.

Fractures, hollows, or roughness in the surfaces of the rack indicate unserviceability.

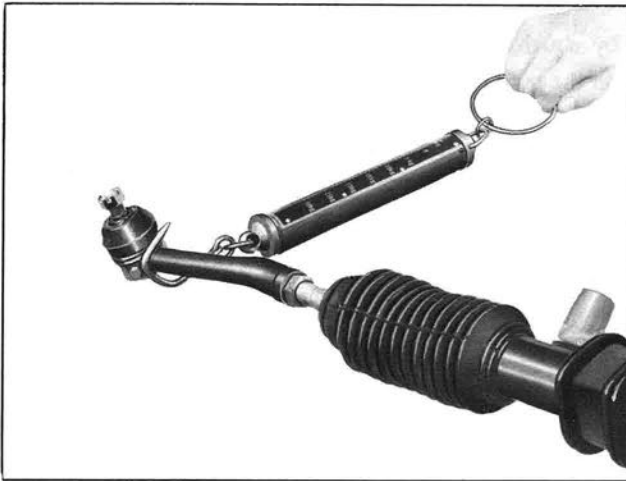
Fig. ST-25 Measuring swinging torque

Measure the swinging torque and axial play. When values are not within the specified ranges, make replacement.

Swinging torque: 0.8 to 1.5 kg-m  
(5.8 to 10.8 ft-lb)

Axial play: 0.06 mm (0.0024 in)

##### Side rod outer ball joint

Axial play: 0.1 to 0.5 mm  
(0.0039 to 0.0197 in)

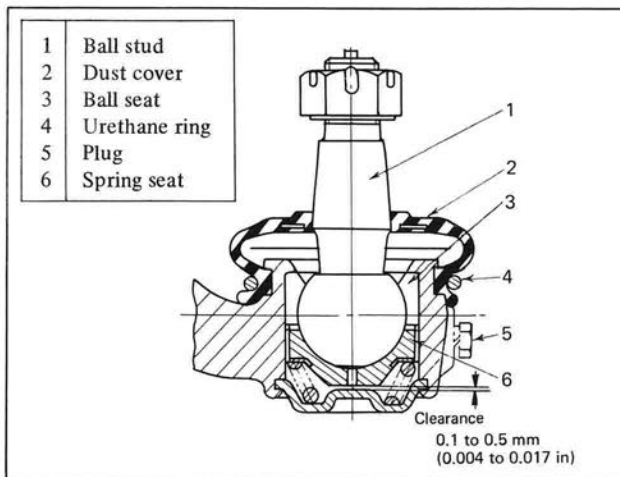
Fig. ST-26 Cross-section of ball stud

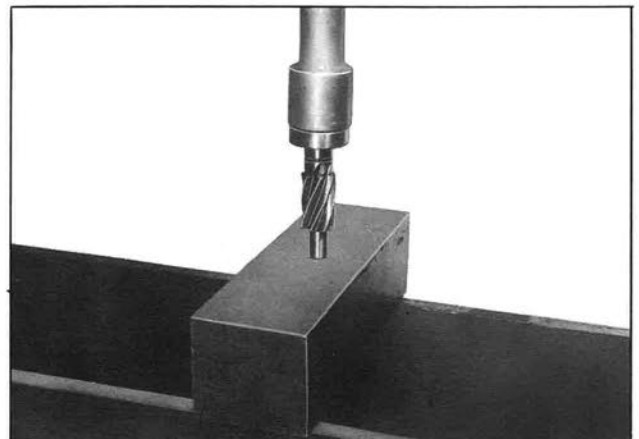
Fig. ST-27 Pressing bearing

1. Press the bearing onto the pinion gear.

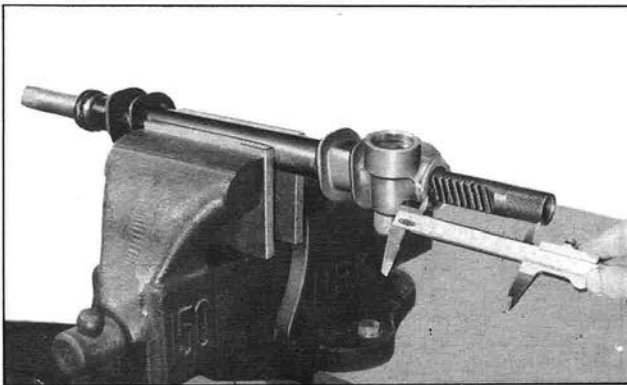
*Fig. ST-28 Measuring protruding portion of rack*

3. Clamp the steering gear housing in a vise.
4. Evenly apply multipurpose NLGI No. 2 grease to teeth and friction surfaces of the rack, and lubricate the gear housing from the pinion housing side.
5. Make sure that the rack protrudes by the same amount from both ends of the housing [96 mm (3.800 in)] and that rack teeth are directed toward the pinion shaft.

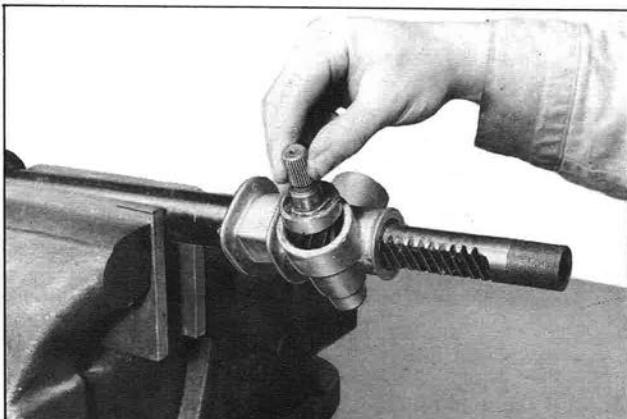
*Fig. ST-29 Inserting pinion*

6. Evenly apply multipurpose NLGI No. 2 grease to the pinion teeth, end bushing, and pinion bearing.
7. Mesh the teeth of the pinion to those of the rack, and insert the pinion without damaging the bushing.

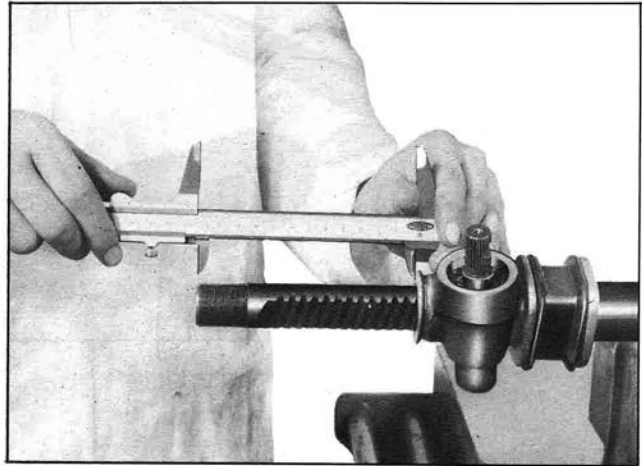
*Fig. ST-30 Measuring protruding portion of rack*

8. Make sure that the rack extends beyond the housing by equal amounts on the left and right, with the groove on the pinion serration part directed upward.

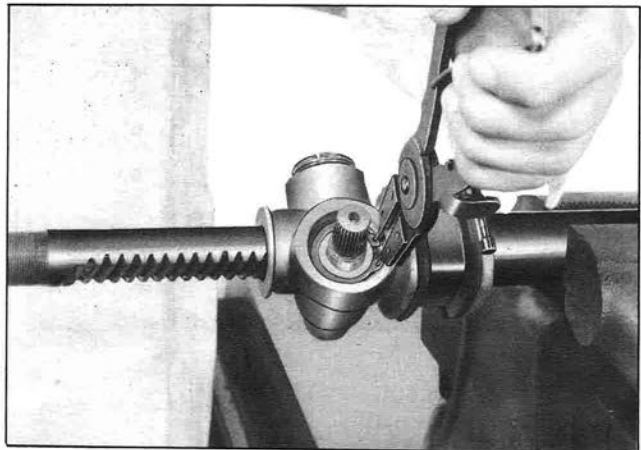
*Fig. ST-31 Fitting snap ring*

9. Fit the snap ring, holding the bearing outer race in place.

**Note:** Carefully fit the snap ring to the housing groove.  
Use the tightest snap ring among the variations.

Thickness	
1.55 to 1.60 mm	(0.0610 to 0.0630 in)
1.60 to 1.65 mm	(0.0630 to 0.0650 in)
1.65 to 1.70 mm	(0.0650 to 0.0669 in)
1.70 to 1.75 mm	(0.0669 to 0.0689 in)

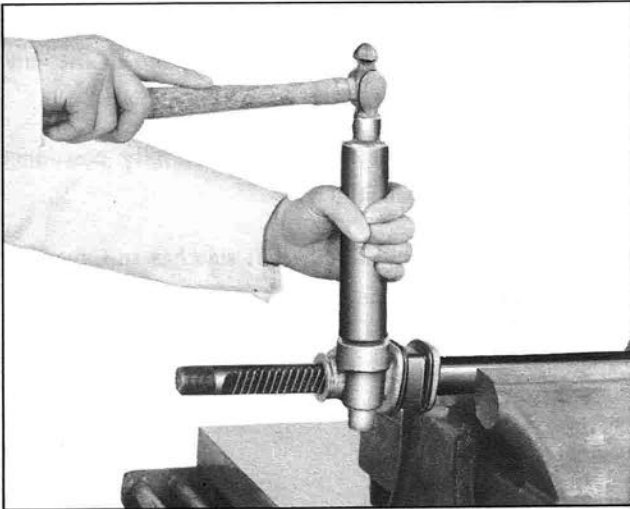
*Fig. ST-32 Fitting oil seal*

10. Fit the oil seal.

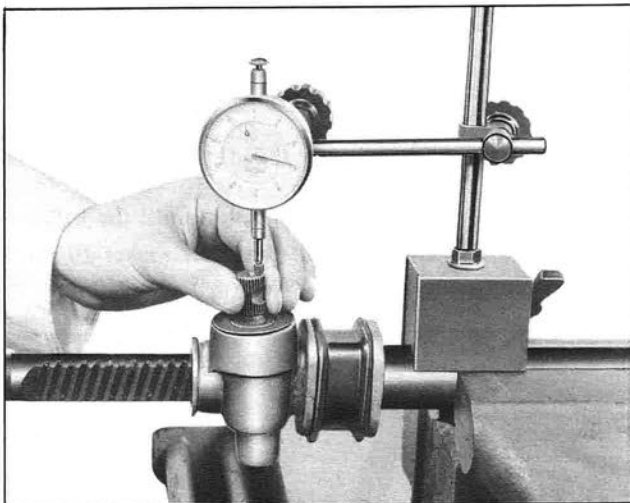
*Fig. ST-33 Measuring thrust play of the pinion*

11. Measure thrust play of the pinion.

Thrust play of the pinion:  
less than 0.09 mm (0.0035 in)

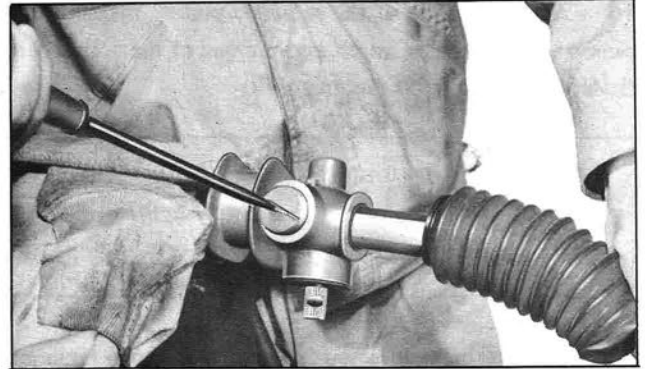
*Fig. ST-34 Threading in adjust screw*

13. Insert the retainer and retainer spring into the retainer hole, and thread in the adjusting screw.

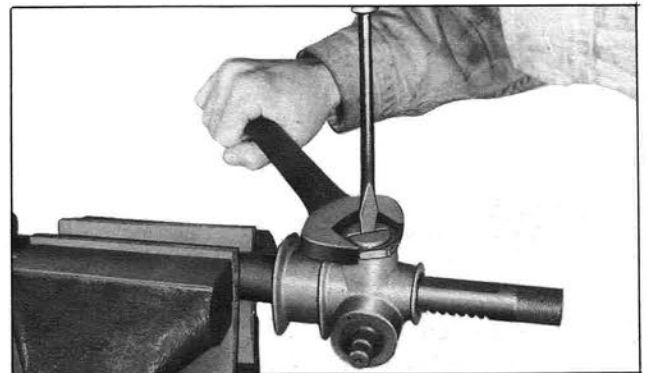
*Fig. ST-35 Locking retainer lock nut*

14. Fully tighten the adjusting screw and back off 20 to 25 degrees. Lock this screw with the lock nut.

Retainer floating play: 0.09 mm (0.0035 in)  
Lock nut tightening torque: 4 to 6 kg-m  
(28.9 to 43.4 ft-lb)

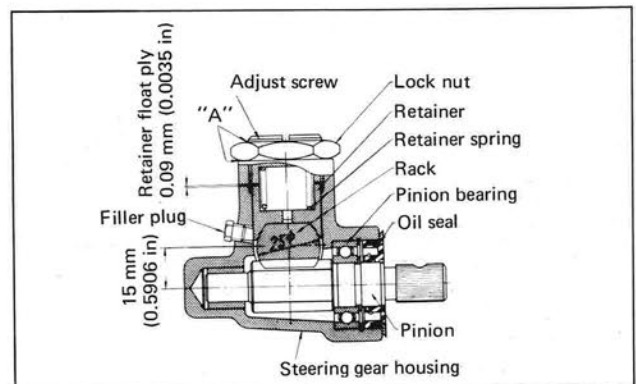
*Fig. ST-36 Area to which liquid packing is covered*

15. After tightening the lock nut, cover liquid packing (Three Bond) around the lock nut at "A".

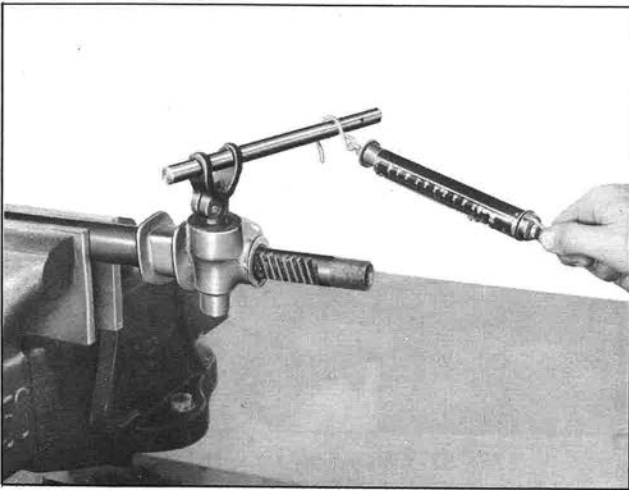
*Fig. ST-37 Measuring pinion rotation torque*

16. After assembly of the rack-and-pinion, measure the pinion torque, pinion angle, and preload of the rack. When these values are not correct, readjust.

Pinion rotation torque:	8 to 20 kg-cm (7 to 17 in-lb)
Rack preload:	8 to 18 kg (17.6 to 39.7 lb)

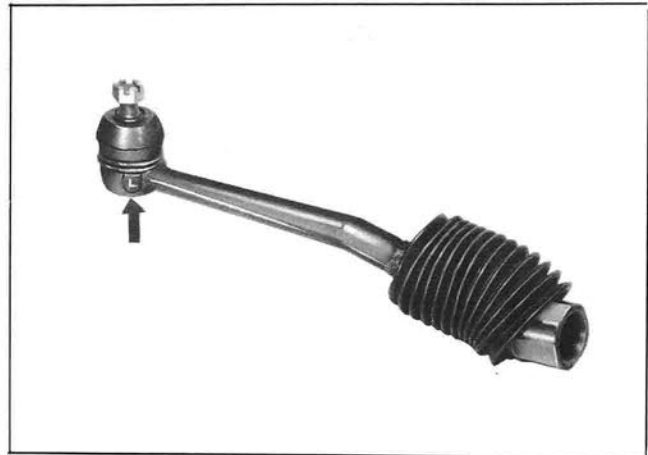
*Fig. ST-39 L-mark*

The side rod assembly for the left side has an L-mark.  
(No mark is used for the right side.)

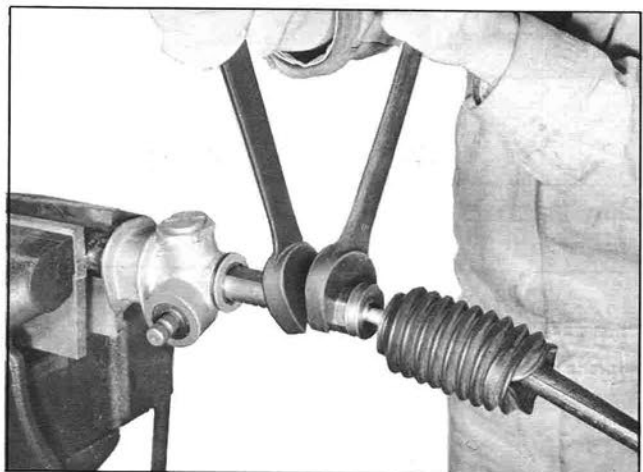
*Fig. ST-40 Locking the stopper nut*

21. Tighten the inner socket portion until the ball seat reaches the rack end, back off the inner socket 20 to 25 degrees, and lock with the stopper nut.

Stopper nut tightening torque:

8 to 10 kg-m (57.8 to 72.3 ft-lb)

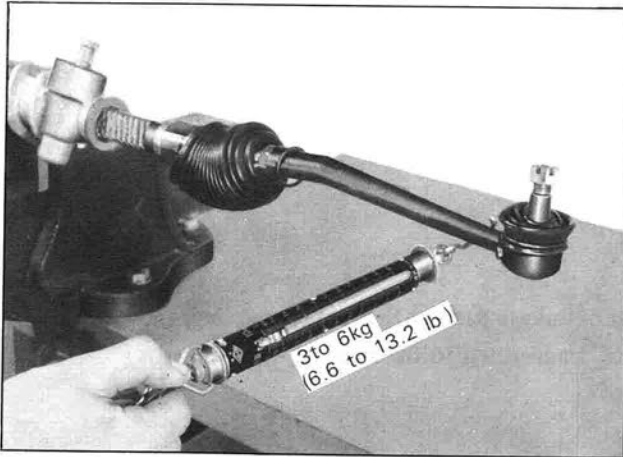
*Fig. ST-41 Measuring swinging torque of side rod assembly*

22. After assembly of the side rod, measure the swinging torque and axial play of the side rod assembly.

Side rod inner ball joint swinging torque:  
(at the side rod end)

3 to 6 kg (6.6 to 13.2 lb)

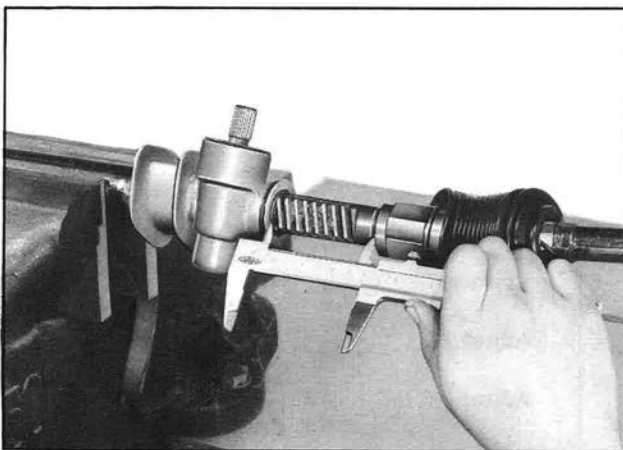
*Fig. ST-42 Measuring rack stroke*

23. Measure the rack stroke.

Rack stroke: 60.7 mm (2.390 in)

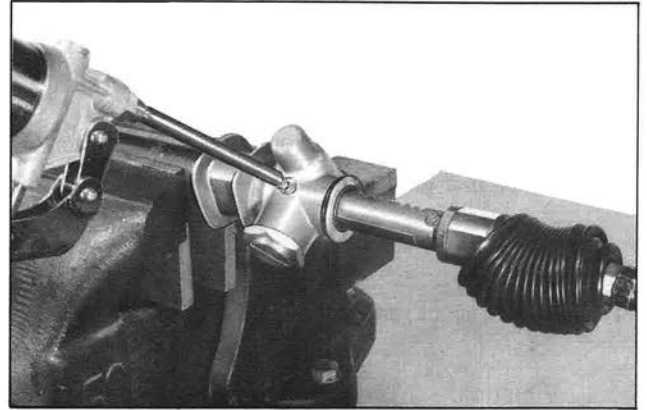
*Fig. ST-43 Supplying the grease*

24. Install a grease nipple at both ends of the rack-and-pinion housing, and apply multipurpose NLGI No. 2 grease to each joint.

**Note:** Lubrication of the rack ends is made so that a small quantity of new grease appears at the boot grease outlet hole, and lubrication of the pinion housing so that a small amount of grease appears between the rack and housing.

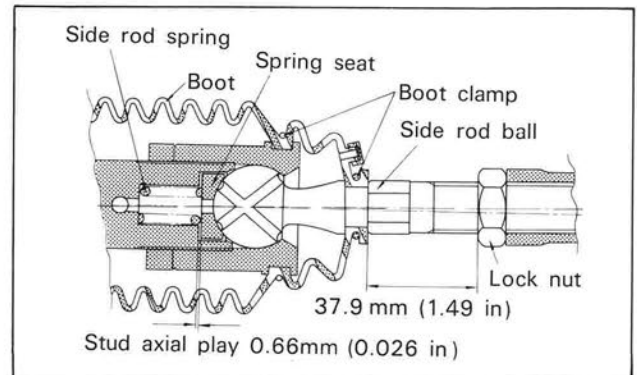
*Fig. ST-44 Side rod*

25. Remove the grease nipple and install the filler plug.
26. Fit the boot.
27. Fill the grease reservoir with multipurpose NLGI No. 0 grease, and attach the reservoir to the rack housing.
28. Adjust the side rod length. (Both left and right).
